Appendix A

Cultural Resources Survey Reports

**PHASE IB CULTURAL RESOURCES SURVEY
OLD ROOSEVELT FIELD
GROUNDWATER CONTAMINATION SITE
VILLAGE OF GARDEN CITY AND
TOWN OF HEMPSTEAD, NASSAU COUNTY
NEW YORK**

**Phase IB Cultural Resources Survey
Old Roosevelt Field
Groundwater Contamination Site
Village of Garden City and
Town of Hempstead, Nassau County
New York**

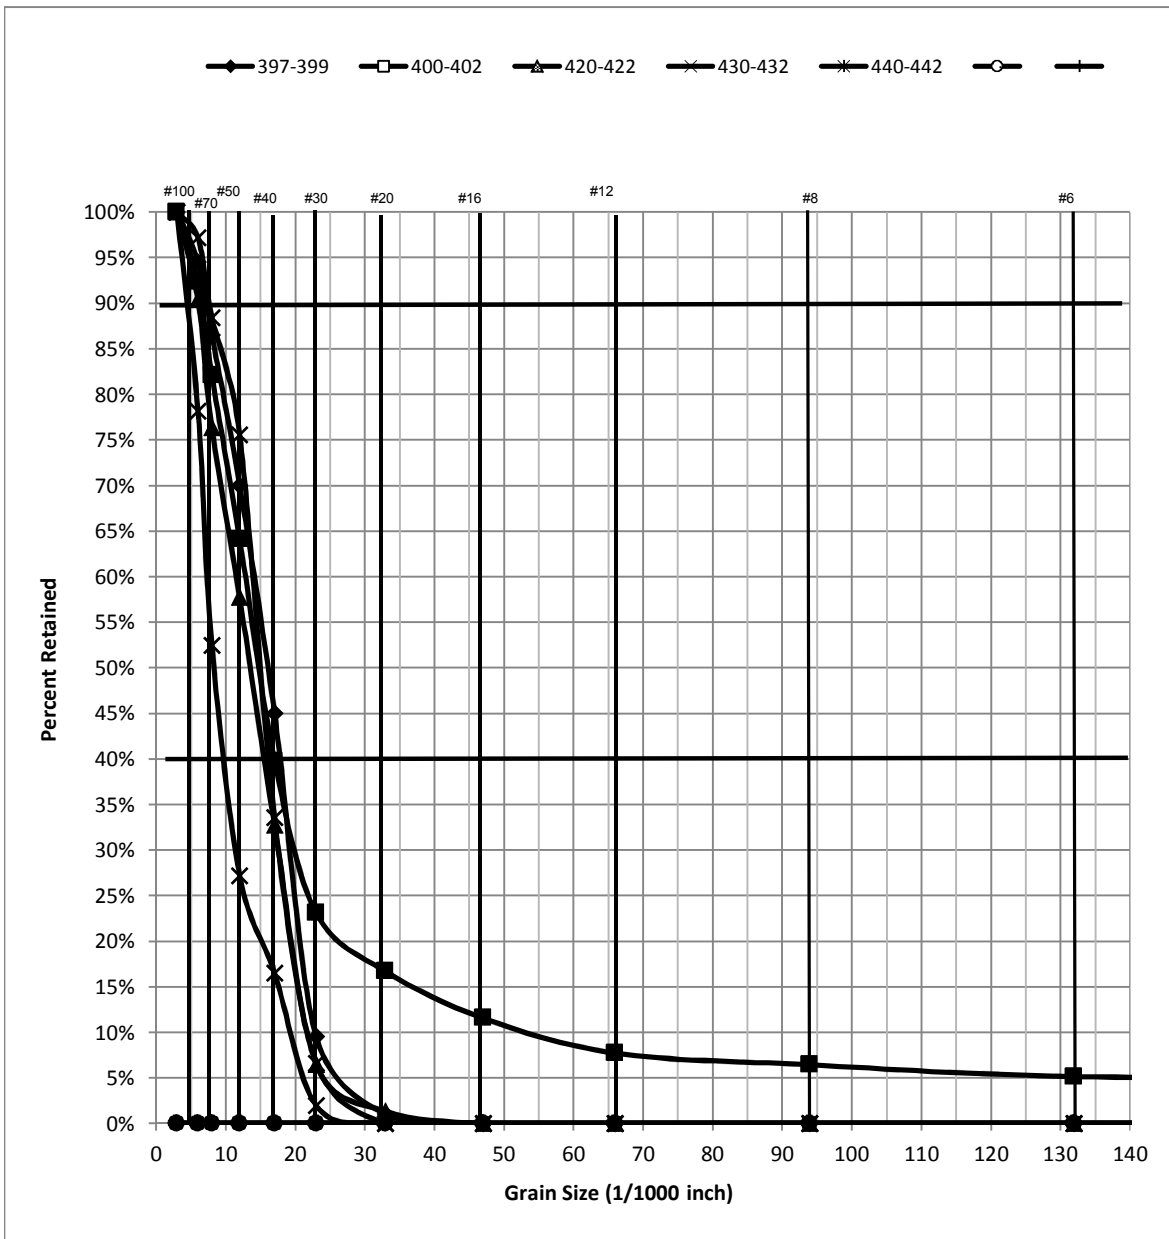
Job Name Old Roosevelt Extraction TB-1

Based exclusively on the samples provided by the contractor, a sieve analysis graph and suggested screen slot size is provided as requested. Since numerous construction considerations and site circumstances influence successful well completion, Johnson Screens assumes no responsibility for final well performance nor awareness of local regulations pertaining to well installations.
